F-4-45  
Martin Warrenfeltz Log House  
Middletown vicinity  
Private

Ca. 1850-1870

# Maryland Historical Trust State Historic Sites Inventory Form

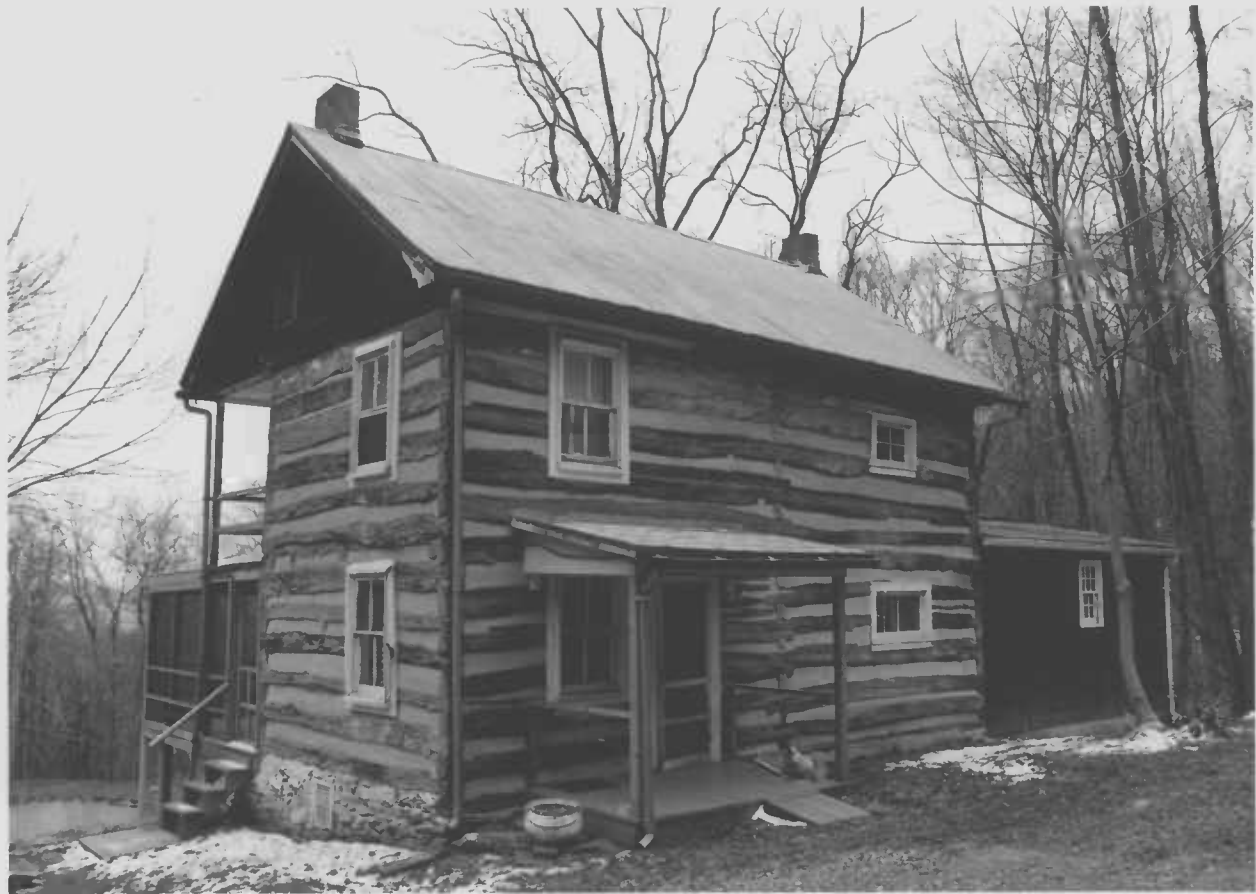
1/4

Northwest corner view

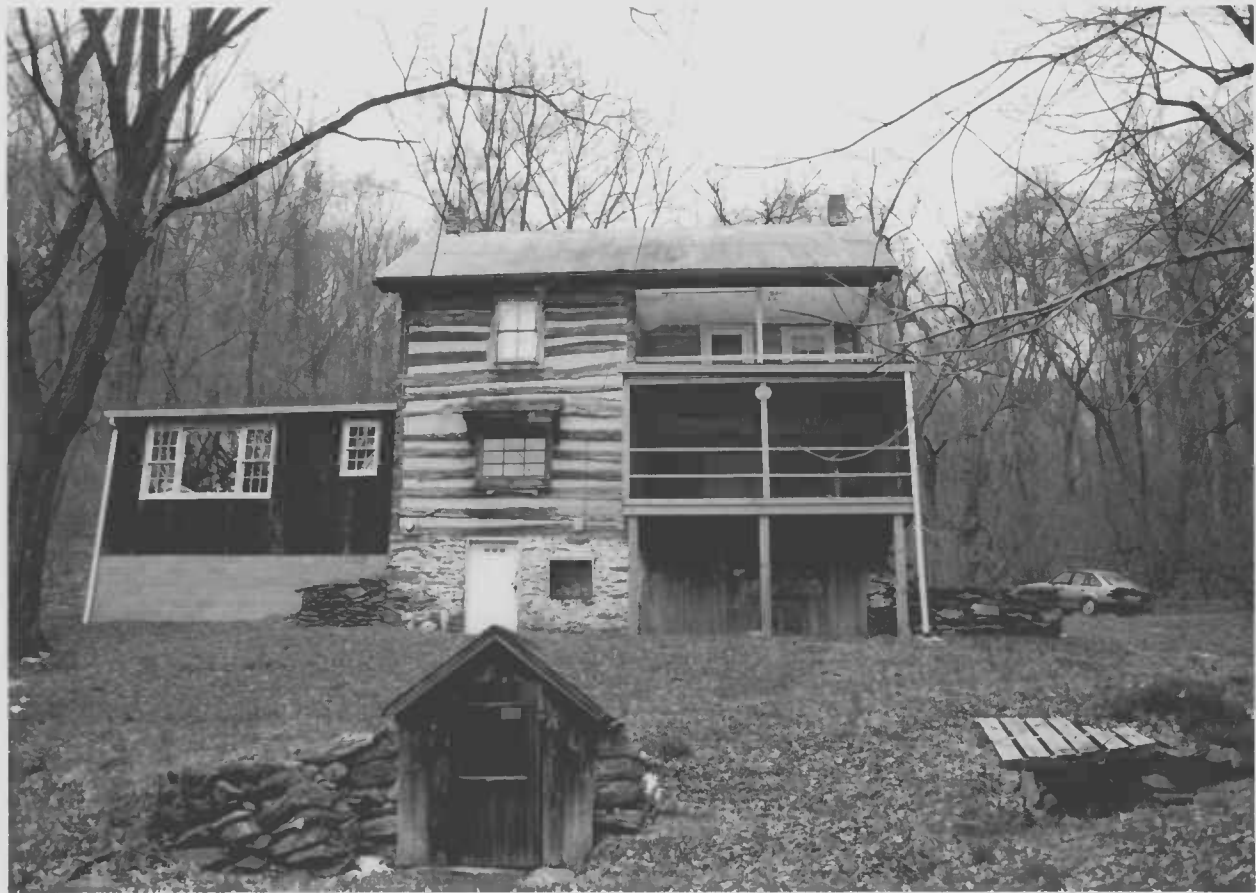
2/4

The house appears to have been built in two sections, possibly about 20 years apart. The first section was a single room, generally square plan building on a stone foundation exposed on the east elevation, with the characteristic V-notching of German vernacular log construction. It may have been a one-story building with a doorway and a window opening on the east and west elevations with the chimney on the south gable end. The second period of construction apparently enlarged the building in both height and width. The addition was made on the south elevation and the pattern of V-notches on the southwest corner of the original section is obscured by the raising of the roof to build the second floor and the integration of the second section. The pattern above the original part includes several half-notched joints secured by nails. On the east elevation, the second section projected beyond the front wall of the first part, leaving an L-shaped angle which is now filled in by a two-story porch under the enlarged roof covering the entire house. The porch has been extended into a screen-enclosed deck on the first story. The stone foundation under the deck has been filled in with concrete block and a modern door is located in the stone foundation of the second section. The doors in the house are four-panel types and may be replacements of the originals. The sash varies, with modern multi-pane replacements in the first floor east elevation and 2/2 in the west elevation, which are probably the original windows. The east elevation of the second section has a central, multi-paned window on the first story with a small wood shingled projecting hood. A small entry porch shelters the door and window on the west elevation. A modern one-story frame addition with vertical siding is located on the south elevation of the house. The roof over the log sections is corrugated metal and interior end chimneys rise above the roof. The new addition has a composition roof. The gable ends of the log section are faced with stained German siding. The interior of the house was inaccessible for this survey.

East elevation

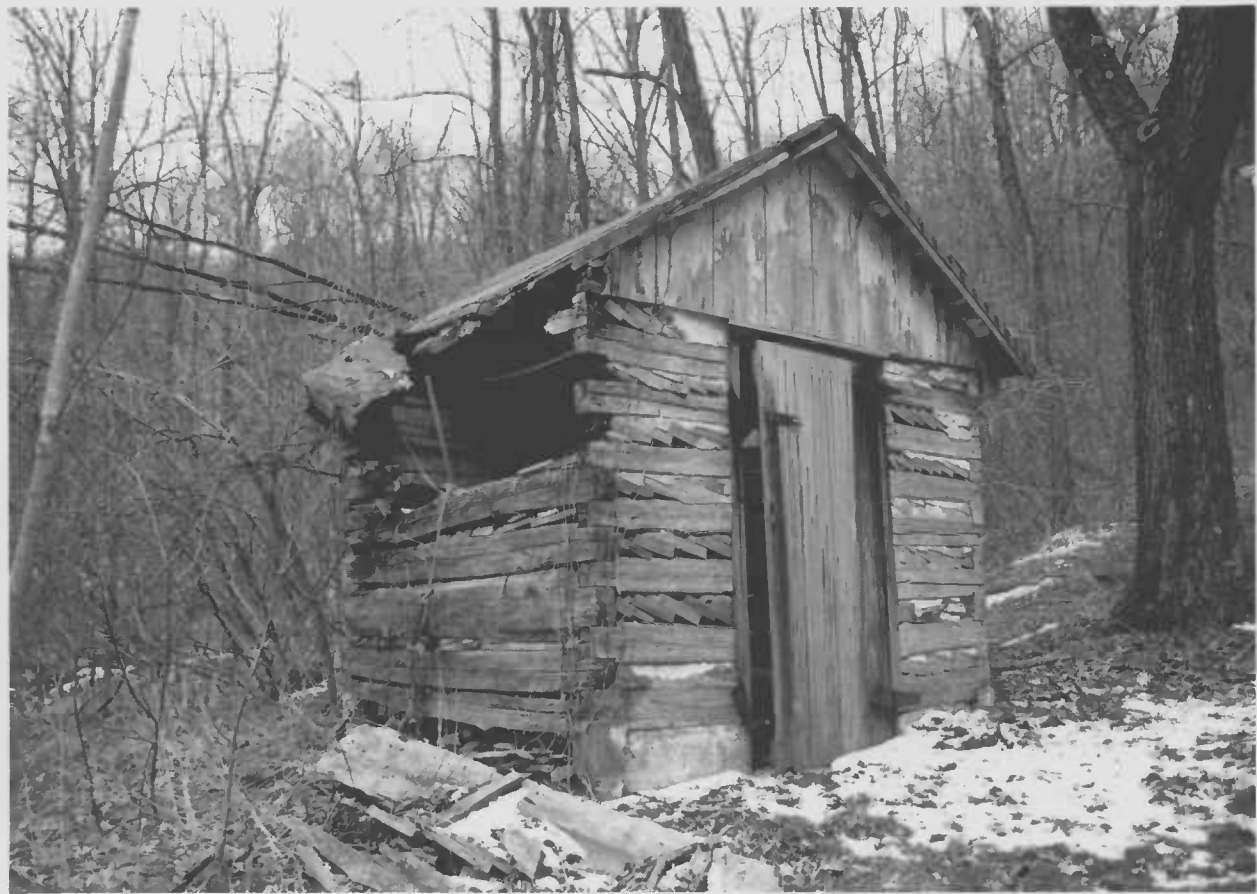
3/4

Meat house: The deteriorated exposed log meat house is located a few yards down the slope east of the house. It has a partially collapsed gable roof covered with composition material. The joinery of the logs is the half notch type of the second section of the house, indicating it was probably built about 1870. The square plan structure has a vertical board door in the north elevation and the gable ends have vertical board siding. The interior has traces of whitewash and two iron cross bars with S hooks.

Meat house, northeast corner view

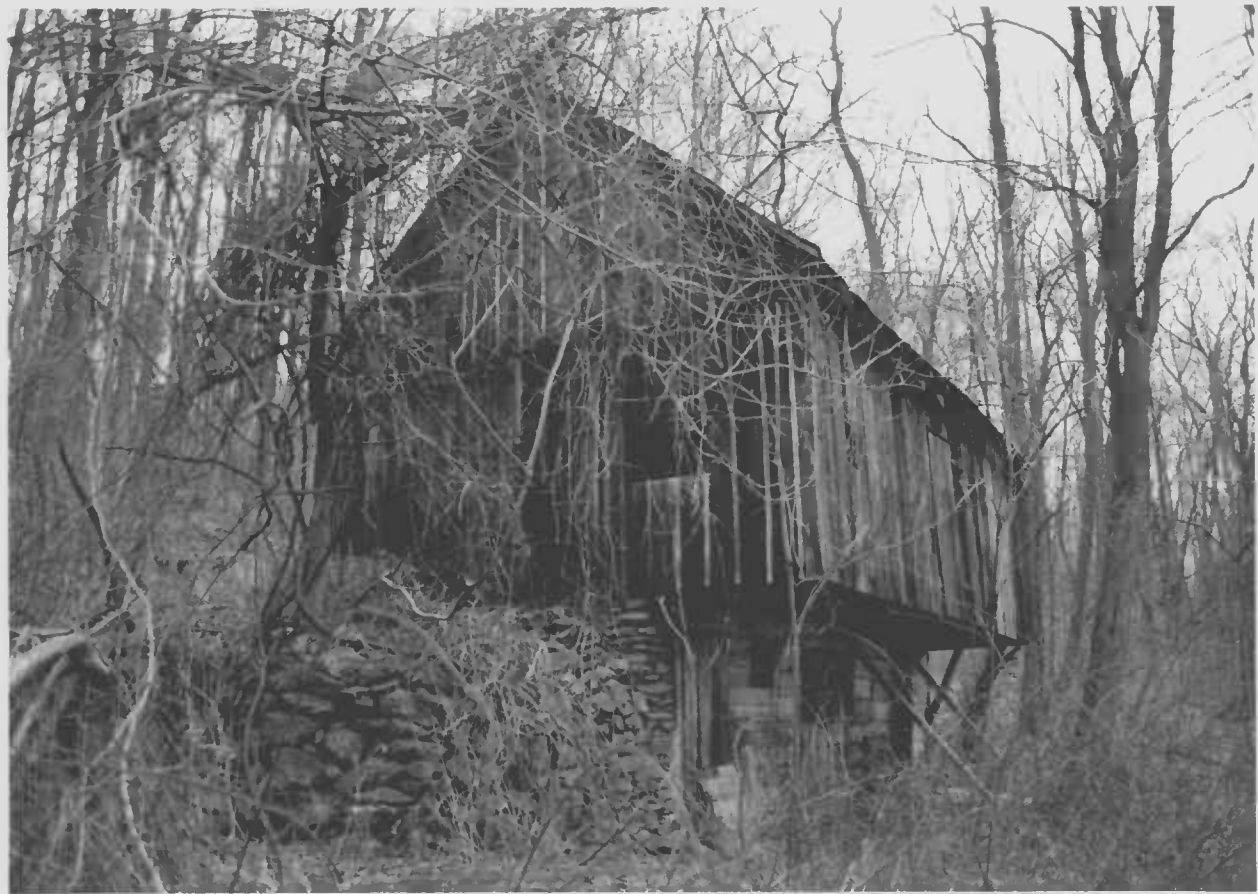
4/4

Barn: The deteriorated frame barn is located on the south side of the access drive from Frostown Road. The stone lower level is banked into the slope below the drive and the hay storage upper level is at the level of the driveway. The barn is a small rectangle in plan with vertical siding on the upper level. A large center opening is located on the north elevation and a vertical board door with iron strap hinges is at the northwest corner. The roof is corrugated metal. The stone lower level on the south elevation has three openings, the center one a dutch door into the stalls and the flanking doors vertical board doors presumably into a feed aisle and a storage area. The lower level is enclosed by horizontal flush boards.

Barri view from west

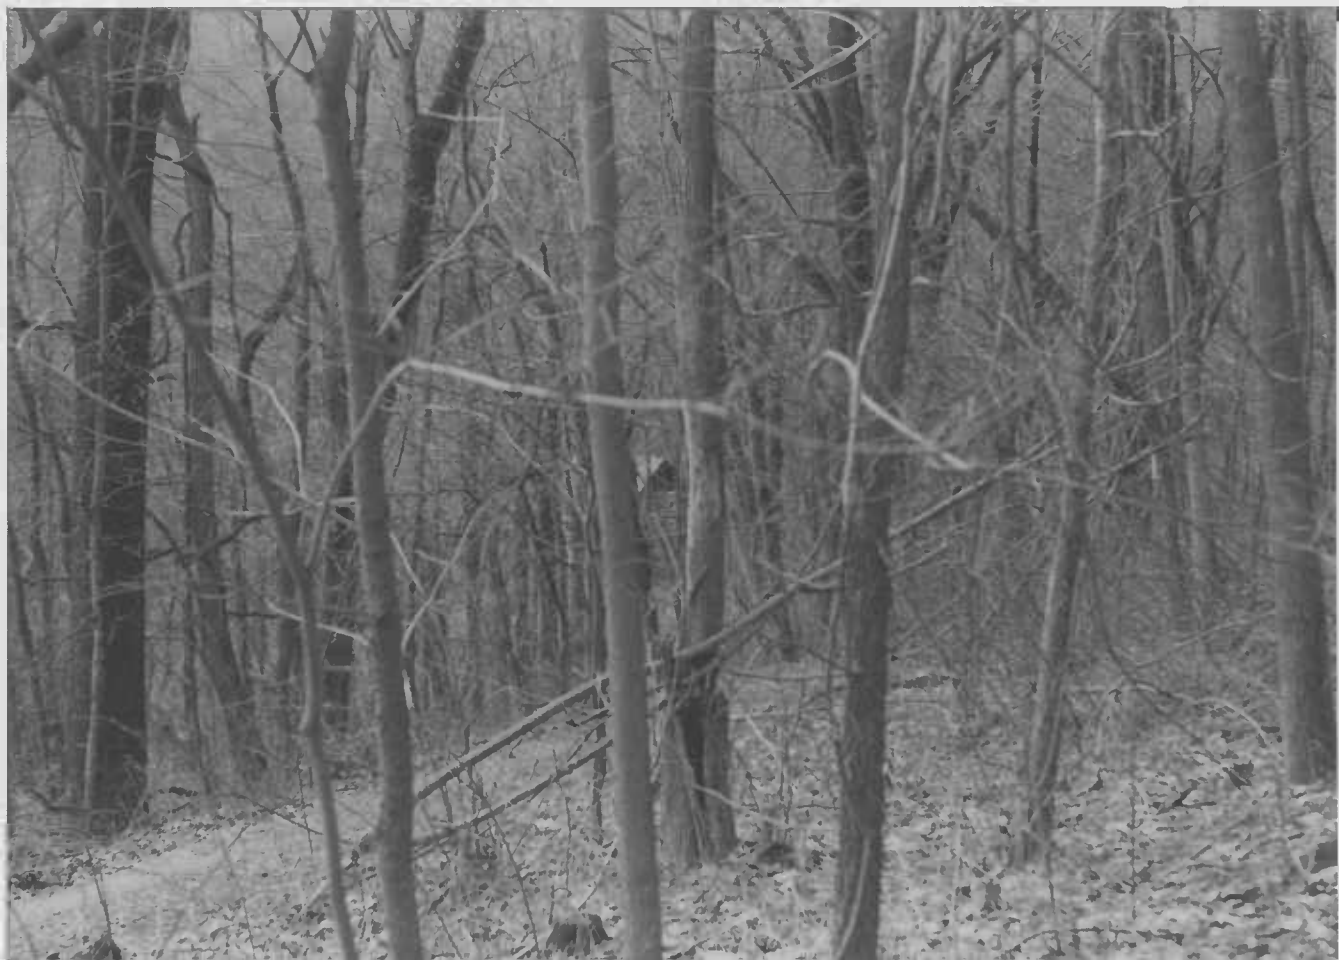
1/2

N elevation of house from Frostown Rd

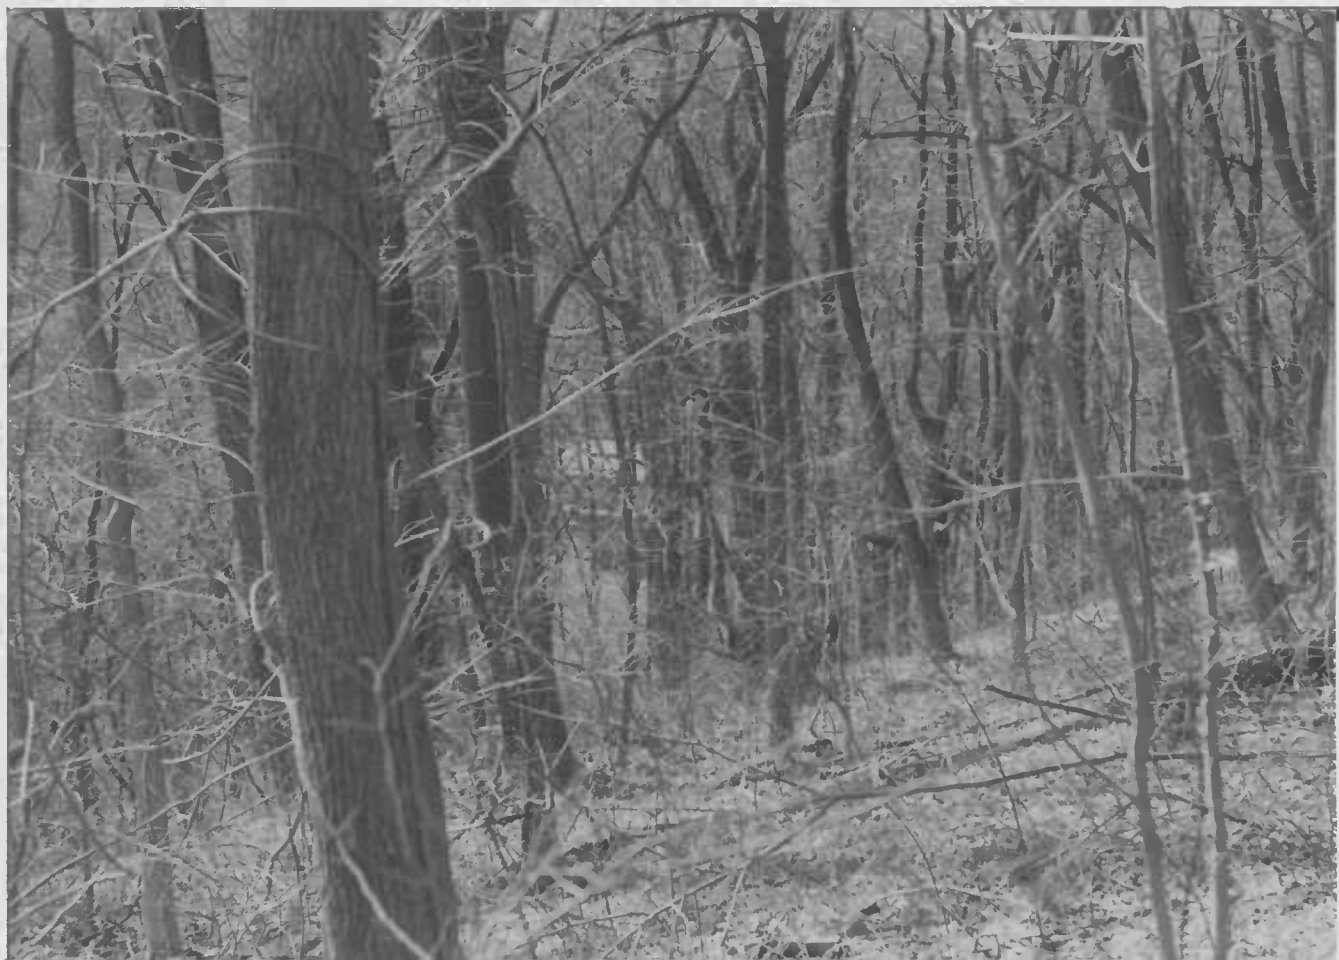
2/2

Elevation of house from Fustum Rd.
